NASA CR-112119-3

EVALUATION OF COATED COLUMBIUM ALLOY HEAT SHIELDS FOR SPACE SHUTTLE THERMAL PROTECTION SYSTEM APPLICATION

PHASE III FULL SIZE TPS EVALUATION

GENERAL DYNAMICS
Convair Aerospace Division

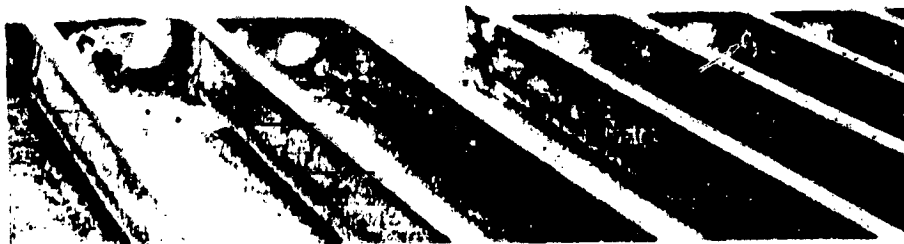
Figure 6-30. Panel with Oxidation Damage and Hole Caused by Coating Deficiencies - 50 Cycles (138710)

3. Coating - Damage identified to have resulted from inadequate quality control of the silicide coating process. This includes the quality of the materials, the distribution of constituents before and after fusing, and the thickness of coating on all surfaces, particularly on interior cylindrical surfaces, edges and corners. Evidence of inadequate coating protection on interior surfaces is seen in Figure 6-26 on the plugs and the post inside diameter of retainer D/R4. Examples of local coating lack of protection are seen in Figure 6-30 which has two damage sites, one hole through a rib and the other an area on the beam web. Figure 6-31 illustrates two cases of edge damage caused by unsatisfactory coating. In Figure 6-32 are seen two other typical damage sites caused by poor quality coating.
